PHOTOGRAPHIC INTERPRETATION REPORT

**SARY-SHAGAN
ANTIMISSILE TEST CENTER, USSR
CHANGES AND ADDITIONS
AS OF**

NPIC/R-923/64

November 1964

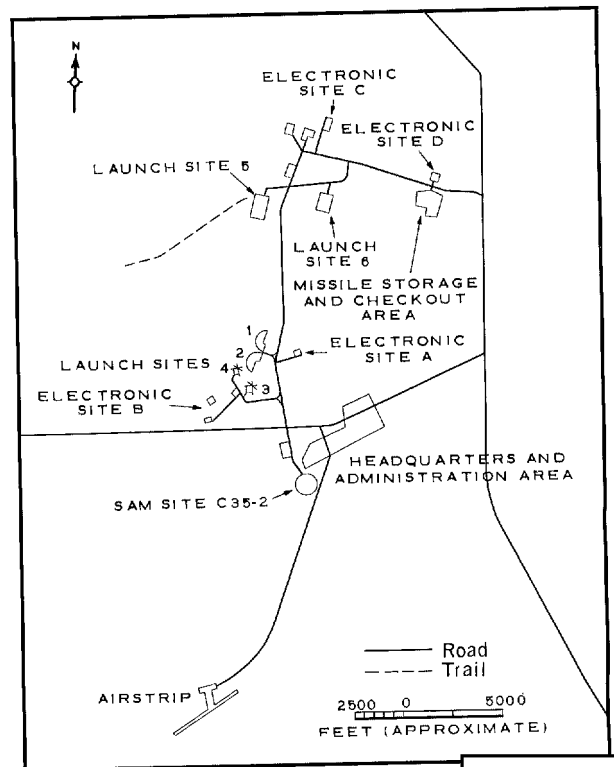
FIGURE 2. LAUNCH COMPLEX A.

No significant change was noted from [redacted] in the Headquarters and Administration Area of Launch Complex A (Figure 2). On [redacted] approximately 15 vehicles were parked just north and north-northwest of the microwave tower in the same location where vehicles were observed in [redacted]. During this period both SAM Site C35-2 and the On-Site Support Facility were active; equipment moved about in both areas and several small structures were added to the Support Facility. Photography of [redacted] reveals a landing T on the airstrip southwest of the Headquarters and Administration Area.

Several of the small structures in the airstrip support area have changed position since clear photography of [redacted].

Facilities remain unchanged since [redacted] at these areas, both of which are active. Approximately 22 vehicles were parked in the Missile Storage and Checkout Area and several probable vehicles were visible in Electronic Site D.

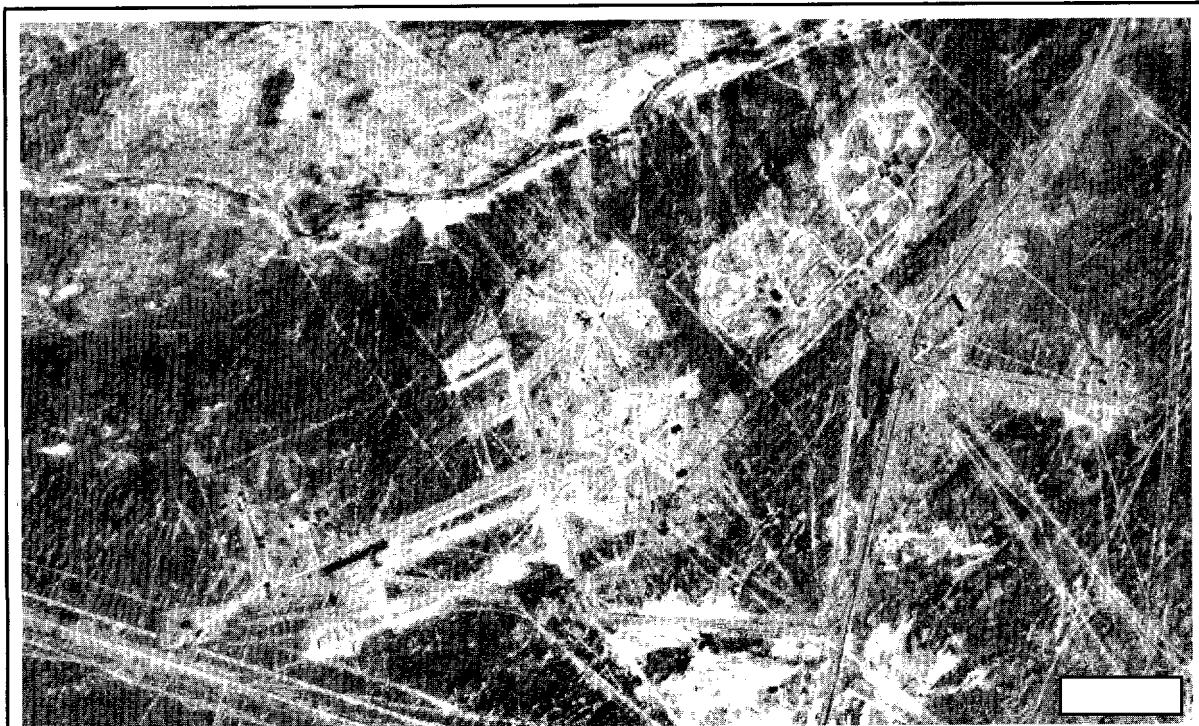
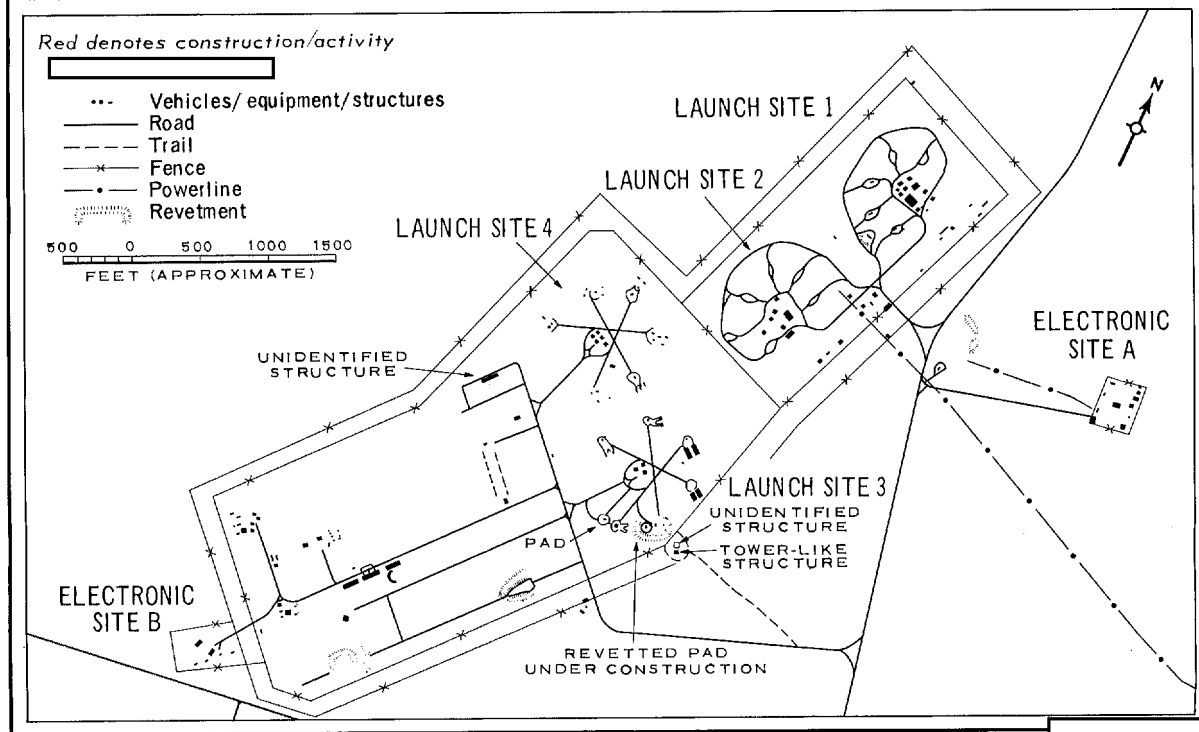
FIGURE 3. LAUNCH COMPLEX A--LAUNCH SITES 1-4 AND ELECTRONIC SITES A AND B.

Launch Site 1. Launch positions are more clearly defined at Site 1 than at Site 2. Only three of the launch positions at Site 1 are occupied. The single hardstand is occupied and appears to be partially enclosed by a low revetment. Four vehicles or very small structures

Launch Site 2. This site does not appear generally as active as Site 1 on [REDACTED] photography. No equipment can be identified at the launch positions. The object with height apparent on the single hardstand since [REDACTED] has disappeared. Two additional vehicles have appeared in the central guidance area since [REDACTED]

Electronic Site A. This site appears essentially as it did in [REDACTED] except that three small structures or vehicles have been added.

Launch Site 3. The two approximately 50-foot by 20-foot objects remain at positions 3 and 4. In the central guidance area one piece of equipment has been removed since [REDACTED]

The small items of equipment found on positions 1, 2, and 6 have been moved during this time. The most significant development has been occurring at position 5, where construction observed as early as [REDACTED] (but not present in [REDACTED]) has now developed into a rectangular revetment with inside measurements of approximately 185 by 65 feet and outside measurements of approximately 225 by 90 feet. The revetment was constructed at the terminal point of the position access road over the site of the former launch position. The azimuth of the perpendicular bisector of the reconstructed pad is approximately 340 degrees. The revetment composes three sides of the reconstructed pad and possibly a short segment of the fourth. A loop road, constructed sometime between [REDACTED] and [REDACTED] serves the position along the fourth side. Uneven terrain, sloping up to the site of the reconstructed pad, has necessitated a gradual buildup of the loop road. Two unidentified pieces of equipment or sheds can

be seen close to the highest point of the loop road. Close to the western inside edge of the revetment, a circular pad (approximately 60 feet in diameter) with a small dark object in the center has been prepared. The remaining revetment floor had not been prepared as of [REDACTED]. Approximately 85 feet east of the revetment a tower-like structure and an unidentified rectangular structure remain in the same position as observed in [REDACTED] and [REDACTED] a second loop road was constructed just west of position 6. Since [REDACTED] a circular pad (approximately 55 feet in diameter) with a small dark object in the center has appeared at the south-east segment of this loop road. A narrow ground scar connects this pad with position 6.

Launch Site 4. All launch positions at Site 4 were occupied by small items of equipment on [REDACTED]. Nine items have been added since [REDACTED] and three have been removed. One item has been removed from the central guidance area.

Electronic Site B. No significant change is discernible in facilities at Electronic Site B since [REDACTED]. Ten additional items of equipment have appeared in the six areas of activity near the western boundary since [REDACTED]

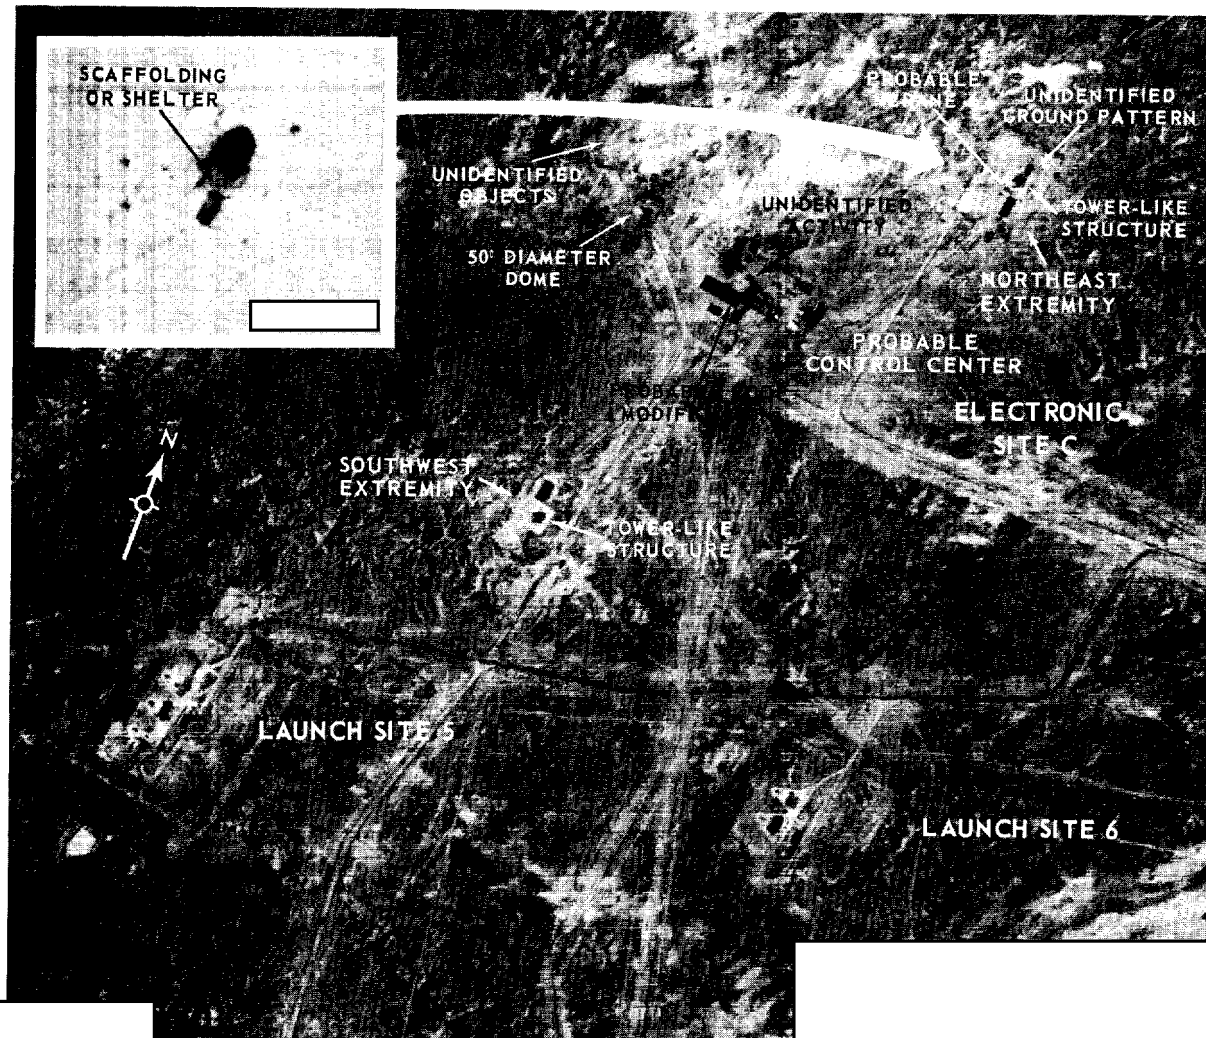
FIGURE 4. LAUNCH COMPLEX A--LAUNCH SITES 5 AND 6 AND ELECTRONIC SITE C.

Launch Site 5. Facilities remain unchanged at this site since []. In contrast with Site 6, this site shows evidence of activity. One vehicle is positioned back of the missile-hold building. Four other vehicles/pieces of equipment are observed in the area.

Launch Site 6. No change is apparent in facilities at the site. No evidence of activity is observed on [] coverage.

Electronic Site C. No change is observed in facilities at the southwest extremity since []. These facilities consist of a probably semiburied building (120 by 70 feet), a tower-like structure on a concrete apron, and several possible vehicles. In contrast, changes have occurred recently at the northeast extremity of this site. The tower-like structure appeared on snow-covered photography of []

[] to have been covered by an environmental shelter or scaffolding (approximately 125 feet high). On photography of [] this shelter has been removed, revealing that the tower-like structure remains standing. The probable crane positioned here since [] is observed at the southwest corner of the apron. An unidentified loop pattern, observed on snow-covered photography of [] just west of the apron, is barely discernible. A dark ground pattern, visible since [] close to the northeast corner of the apron, still is apparent and remains unidentified. Several vehicles are noted at the site.

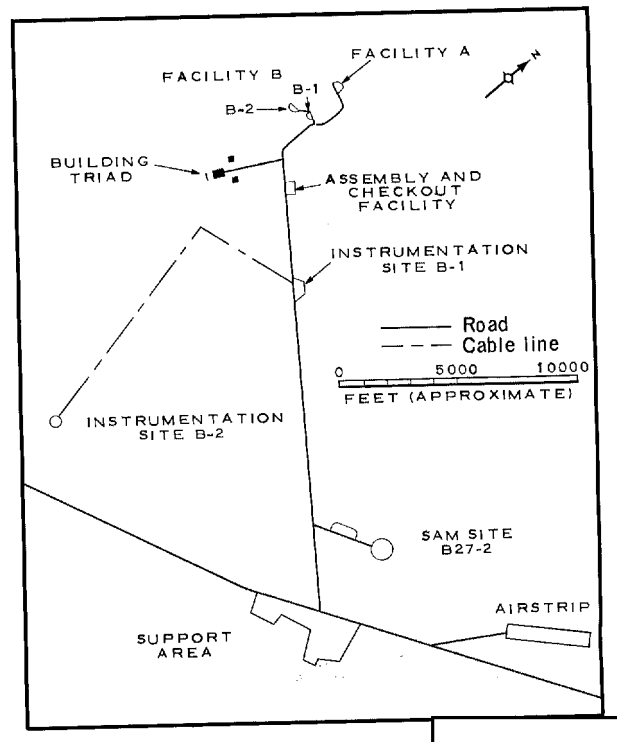
FIGURE 5. LAUNCH COMPLEX B.

No significant change has been observed since the latest clear coverage of [] in the Support Area, in the Assembly and Checkout Facility, in the airstrip, or in the four instrumentation sites serving Launch Complex B (Figure 5).

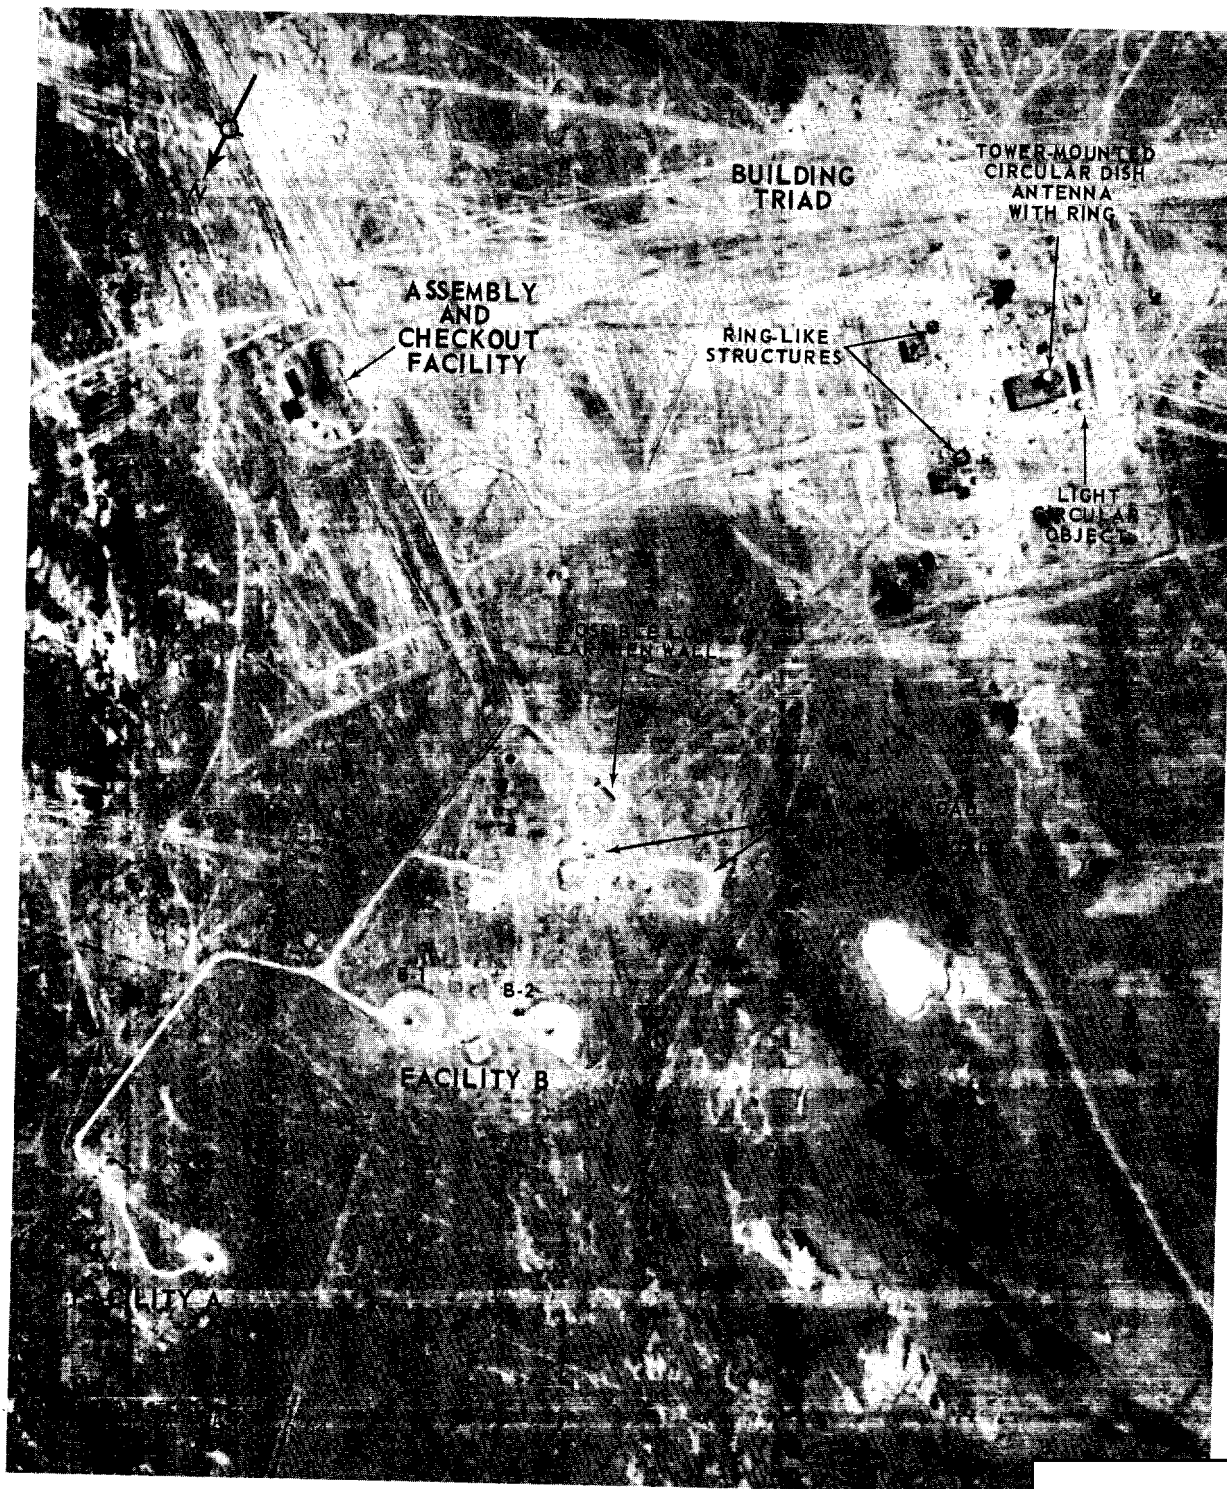
FIGURE 6. LAUNCH AREA AND BUILDING TRIAD AT LAUNCH COMPLEX B.

Facility A. Facility A remained unchanged since latest clear coverage of []

Facility B. No significant change has been observed since [] in Pads B-1 and B-2. What appears to be a low, narrow earthen wall or earth mound [] now is apparent along the south lip of the loop road near the south-central boundary of Facility B at the point where the scar from the triad reaches it. A second loop road was constructed between [] (possibly under construction in []) -- just west of the first one and connected with it by a road 250 feet long. The major axis of the area enclosed by the eastern loop road measures 260 feet; that enclosed by the western loop road 270 feet. The western road has been constructed through the inner of the two security fences around Facility B. A number of vehicles can be seen in the area, including two probable vehicles parked adjacent to Pad B-2.

Building Triad. The building triad at Launch Complex B remains under construction and is now believed to be electronic in nature. The previously reported tall dish- or disc-like object on the roof of the large rectangular building of the triad is now confirmed as a tower-mounted circular dish antenna (approximately [] in diameter). A ringlike structure, [] in diameter, is on the roof, encircling the tower and probably indicating preparations for an environmental shelter. Smaller ringlike structures (75 and 65 feet in diameter) are positioned on the ground adjacent to the northern and southern small triad buildings, respectively. A small object is observed on the roof of each of the smaller buildings. Adjacent to the unidentified structure paralleling the large triad building is a light-colored circular object (approximately [] in diameter), possibly an

environmental shelter. A ringlike structure, [] in diameter, is also observed on the ground just north of the northern small triad building. Three generally circular excavations are visible just southeast of the large triad building. At the triad site are a number of small structures, some of which are new since []. The unusual road pattern east of the two small triad buildings appears essentially as it did in [].

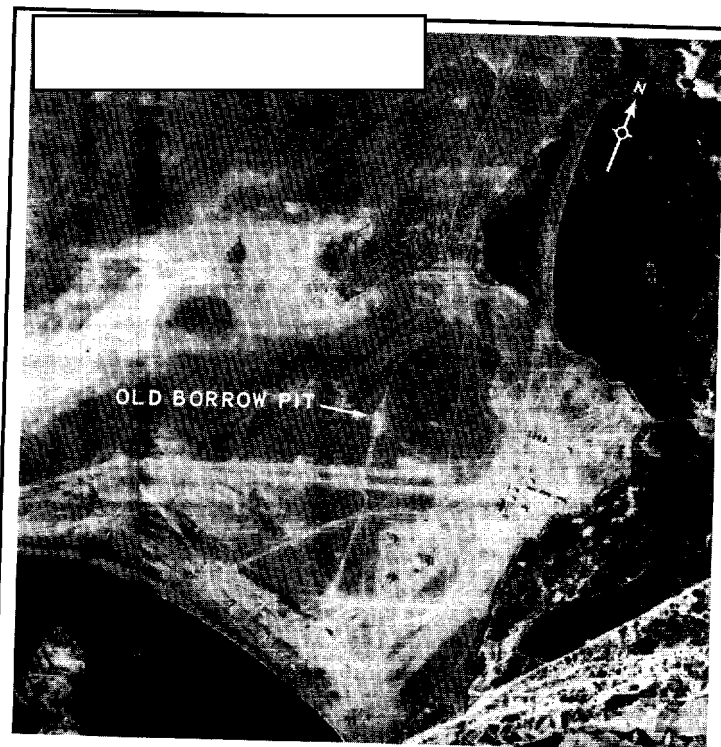
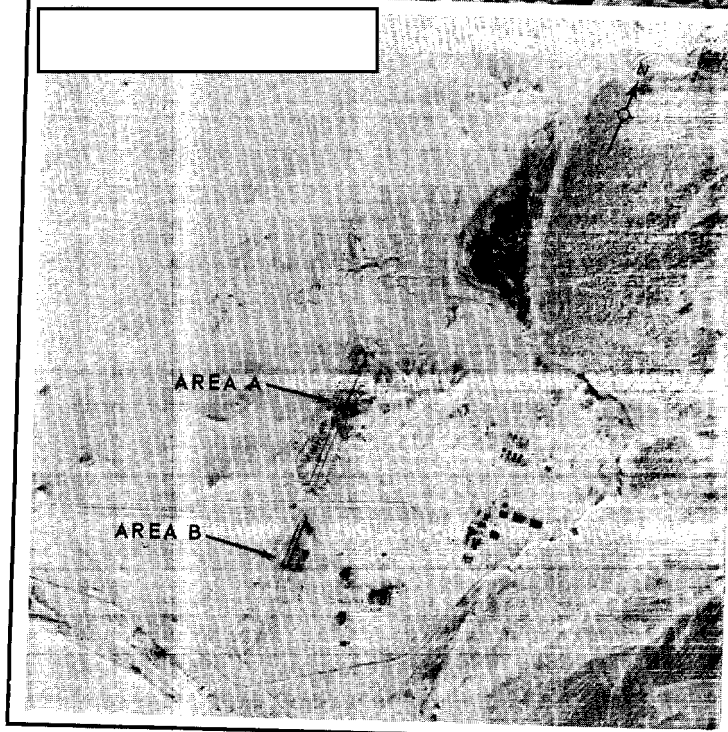
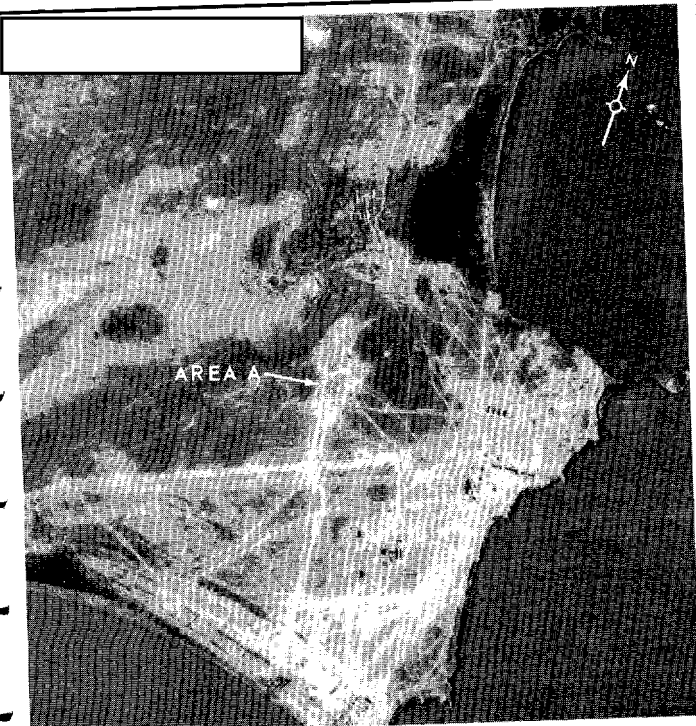
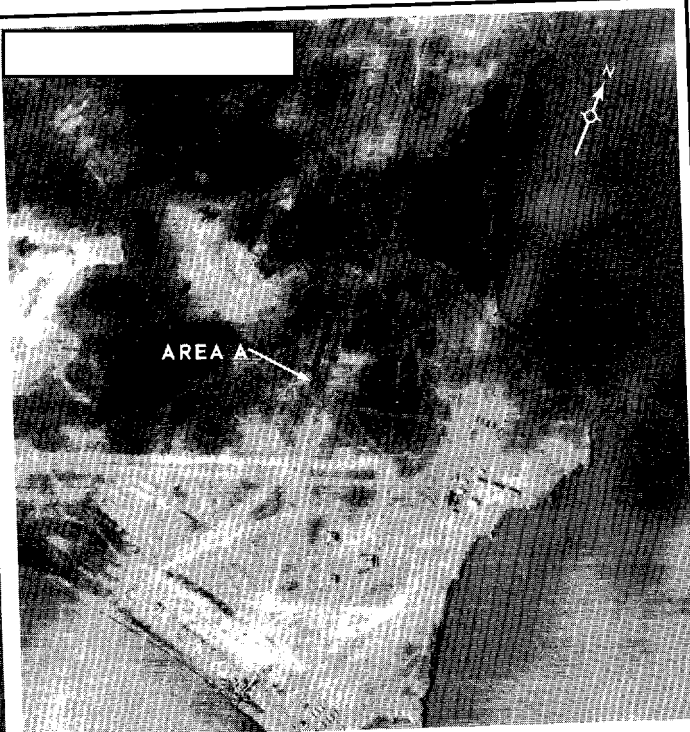
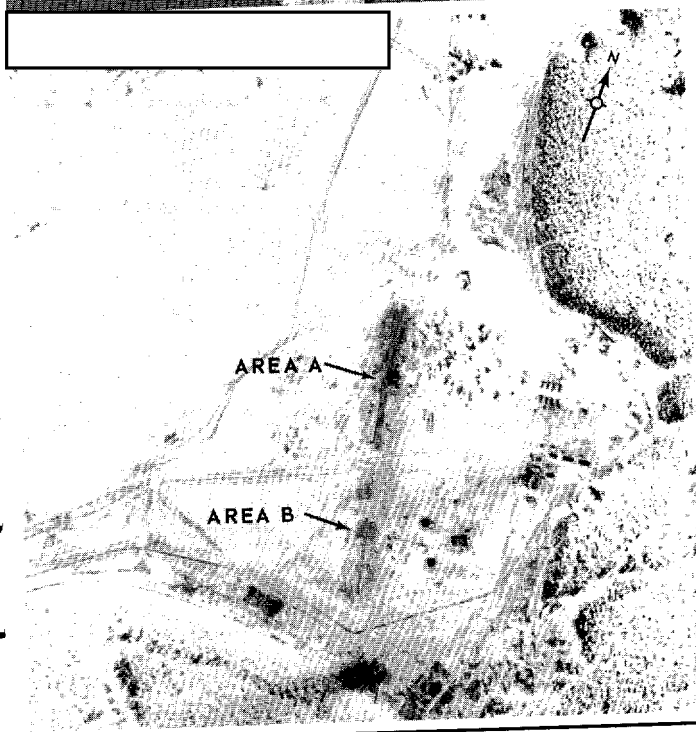
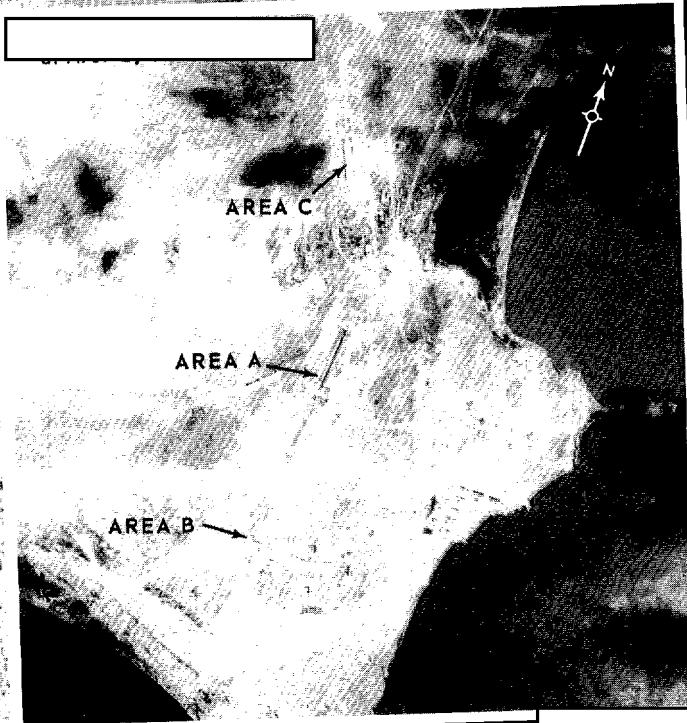
DEVELOPMENT OF HEN HOUSE-TYPE STRUCTURES AT SITE 13, SSATC.

Between the [] report 1/ and [] the primary change of significance at Site 13 occurred at the dual HEN HOUSE-type structures, with minor construction in the support areas (Figures 7, 8, and 9). Extensive development was accomplished on the two previously observed linear structures, revealing increased similarity in size and configuration to the original HEN HOUSE antenna at the SSATC Support Base. In this report they will be referred to as dual HEN HOUSE-type structures. Each structure consists of a dual HEN HOUSE-type antenna in various stages of construction and a probable central control build-

ing. The two dual structures appear to be parallel and in line with a separation distance of approximately 250 feet. The azimuths of their perpendicular bisectors are both [REDACTED]

[REDACTED] Sometime between [REDACTED] construction of a third such structure (Operations Area C) was started approximately 2,160 feet north-north-west of the most advanced site (Operations Area A). This structure is offset from the other two structures, with the azimuth of the perpendicular bisector of the structure being [REDACTED] degrees [REDACTED]. There is no evidence to date of a fourth such site.

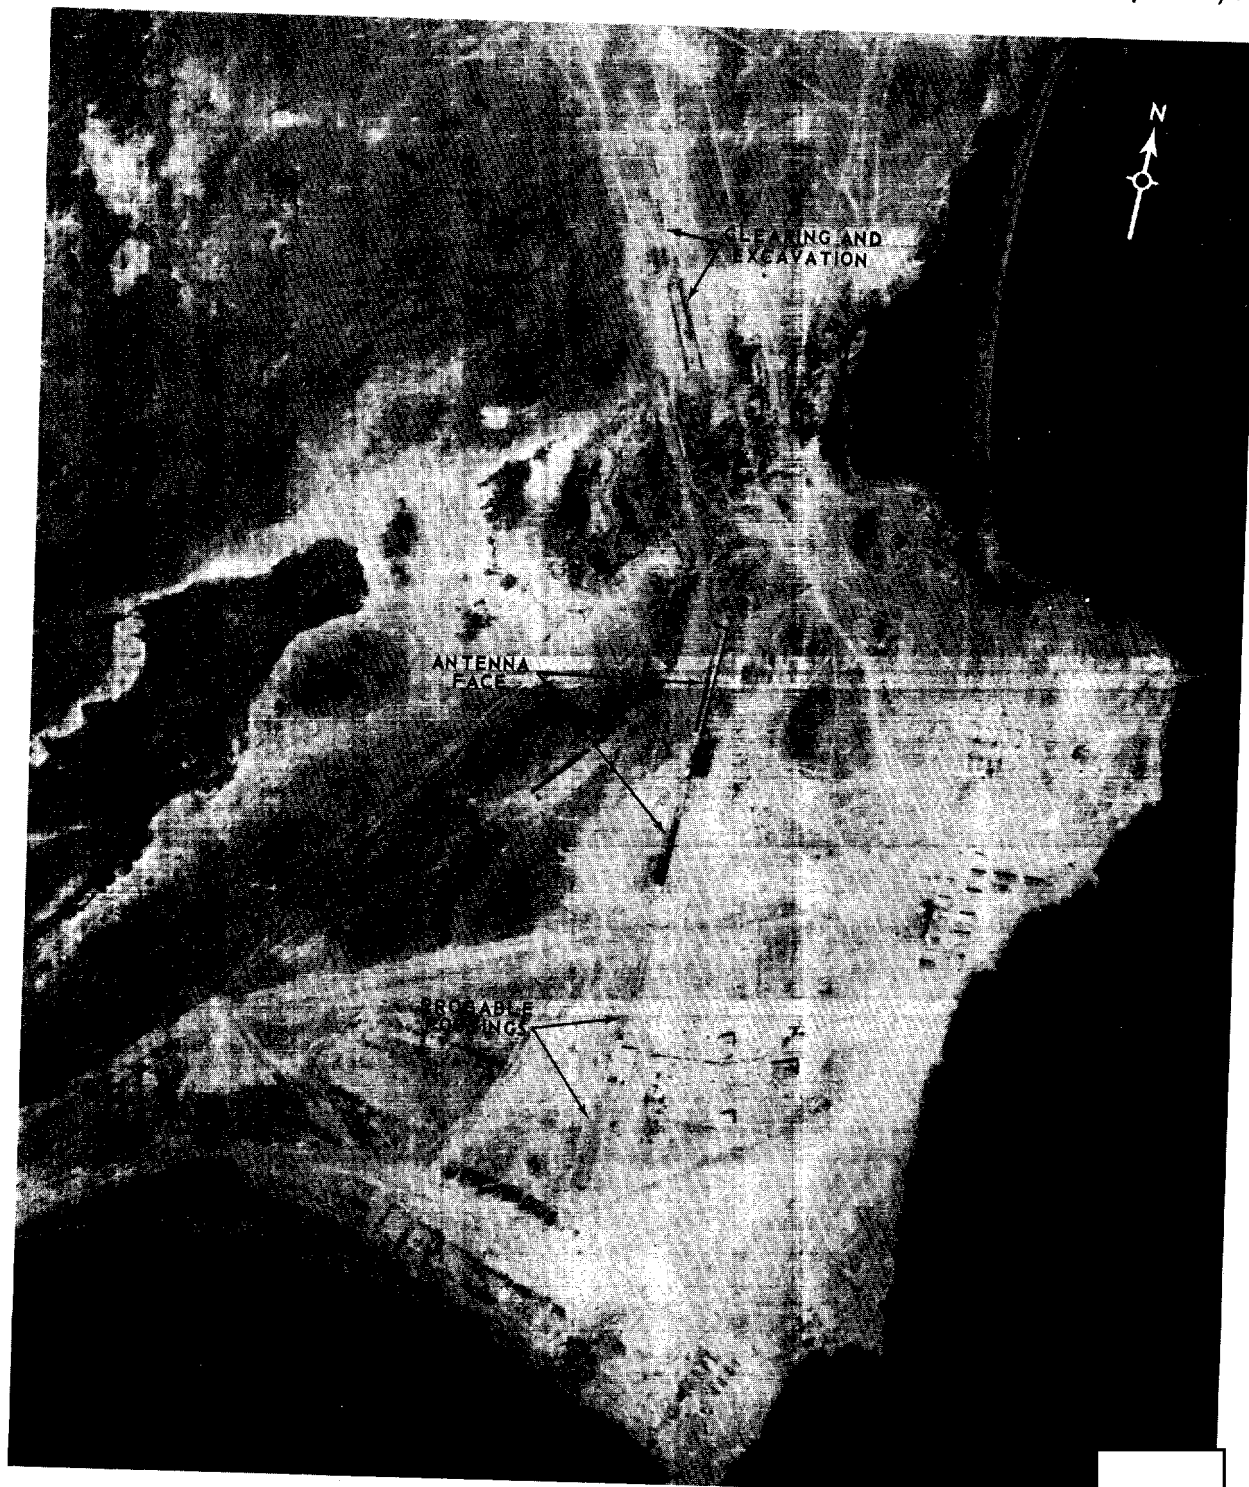
FIGURE 8. SITE 13, SSATC.

On Mission [] work continues on the probable central control building at Area A. The exterior of the northern linear pitched-roof structure at Area A is almost complete except for a short segment of the north end. What appears to be the antenna face is oriented toward the west. Roofing is just beginning on the northern portion of the southern linear structure of Area A.

Excavation of both linear excavations of Operations Area B is observed on this mission, with a narrow linear strip at the base of each excavation. Footings or excavations for footings are present in both excavations. A terminal building (85 by 55 feet) is under construction at the northeast end of the northern linear structure. The probable central control building (approximately 280 by 125 feet) is in a relatively advanced construction stage.

Observed under construction for the first time on this mission is the third dual HEN HOUSE-type structure. Clearing, with minor excavation, is taking place at both linear sites at Area C. Preliminary work is noted at the site of the probable central control building (approximately 245 by 215 feet). In contrast with similar buildings at Areas A and B, the bulk of the probable central control building at this area is positioned to the west of the linear structures. This site was cloud covered on Missions []. No indication of such construction was discernible on snow-covered photography of [].

On Mission [] the northern linear structure at Operations Area A appears complete externally, with the antenna face oriented westward. Work is apparently in progress on the antenna face, which is half dark and half light in tone. Approximately one-half of the

southern linear structure at Operations Area A appears roofed and the roof would indicate that this antenna face would also face westward. A terminal building (85 by 55 feet) is now noted at the southeast end of the southern linear structure of Area A. Work continues on the probable central control building at both Areas A and B. Construction details of the two linear structures at Area B are not apparent because of heavy haze; however, footings appear to have been erected in both linear excavations. Excavation continues throughout the length of the two linear excavations at Operations Area C, with a possible linear strip noted at the base of each excavation. Storage near Area A has increased since Mission [] to a length of approximately 825 feet.

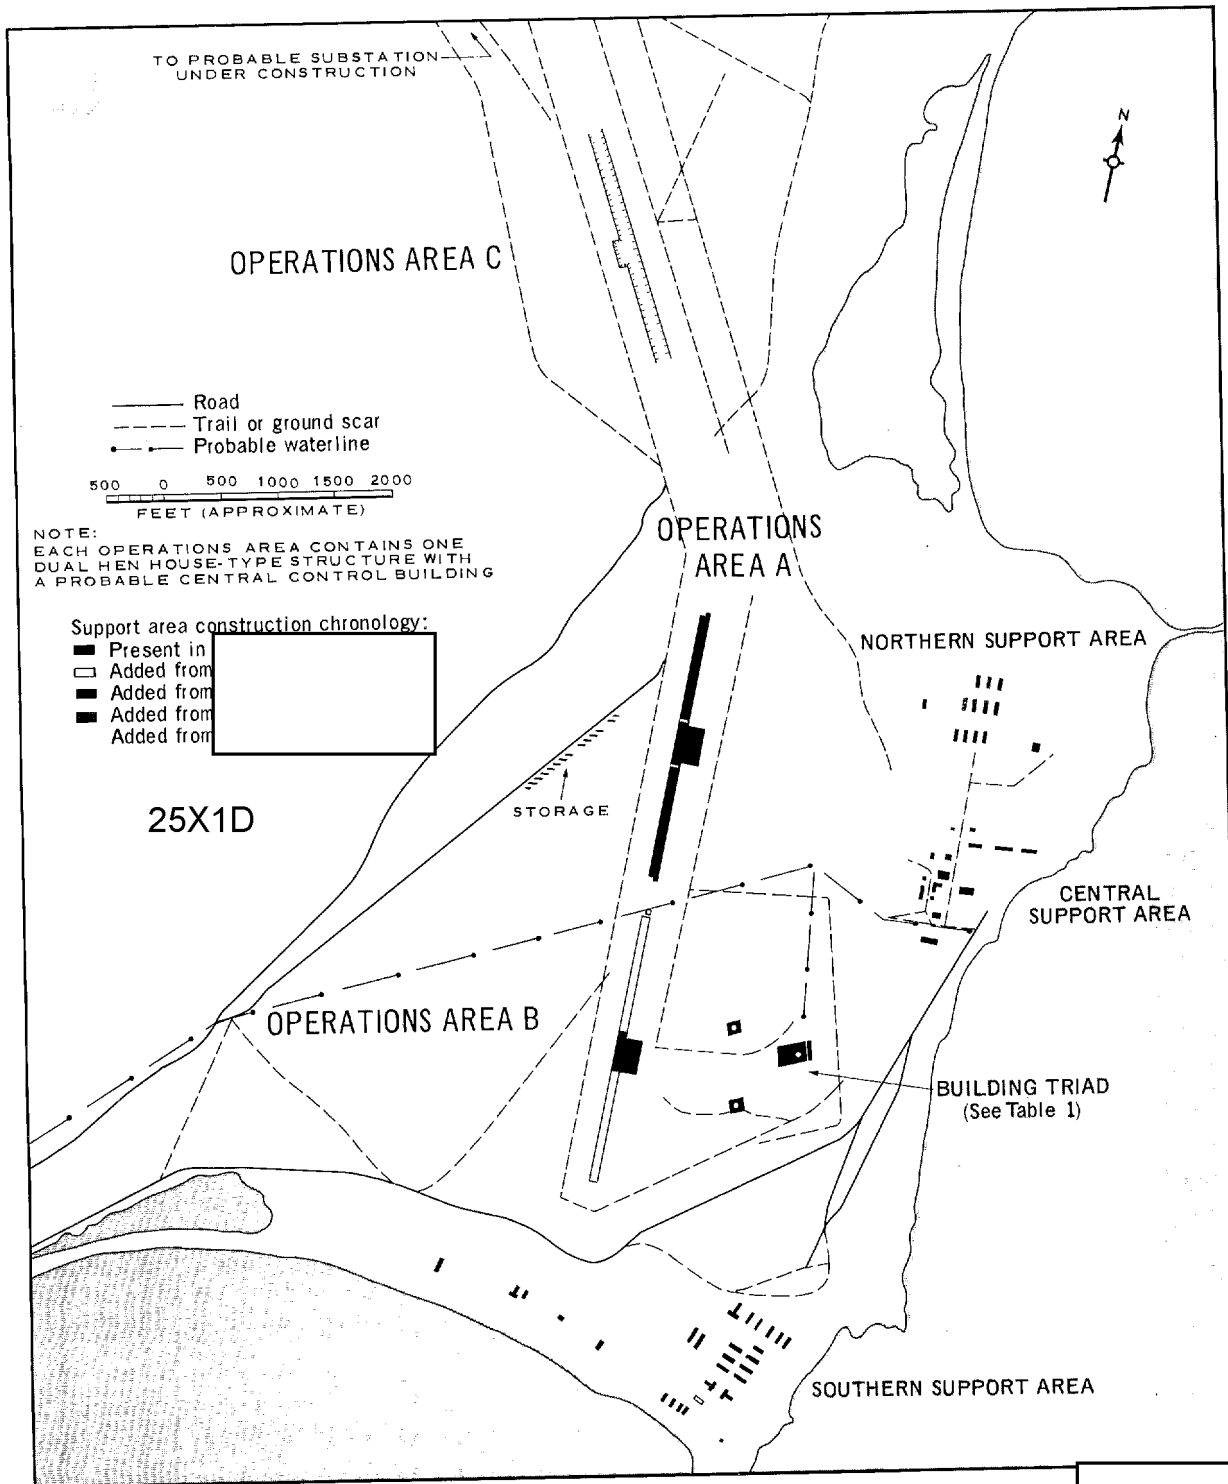
FIGURE 9. LAYOUT OF SITE 13, SSATC,

Figure 9 portrays the construction chronology of support facilities at Site 13, which totalled 61 buildings in [REDACTED] and which would service both the building triad area and the dual HEN HOUSE-type structures. These support facilities fall into three areas without any clearly drawn line of differentiation with respect to the two different types of operational areas.

No support buildings existed at the site in [REDACTED]. By [REDACTED] 27 support buildings had been erected in the three areas

and the three triad buildings were visible for the first time. Only one additional building appeared by [REDACTED]. Since that time relatively slow, steady construction has taken place, primarily in the northern and southern support areas and consisting largely of barracks-type buildings. From [REDACTED] a total of 33 support buildings were constructed: 8 from [REDACTED], 19 from [REDACTED], and 6 from [REDACTED]. It is of interest that the three dual HEN HOUSE-type structures were first observed under construction in [REDACTED].

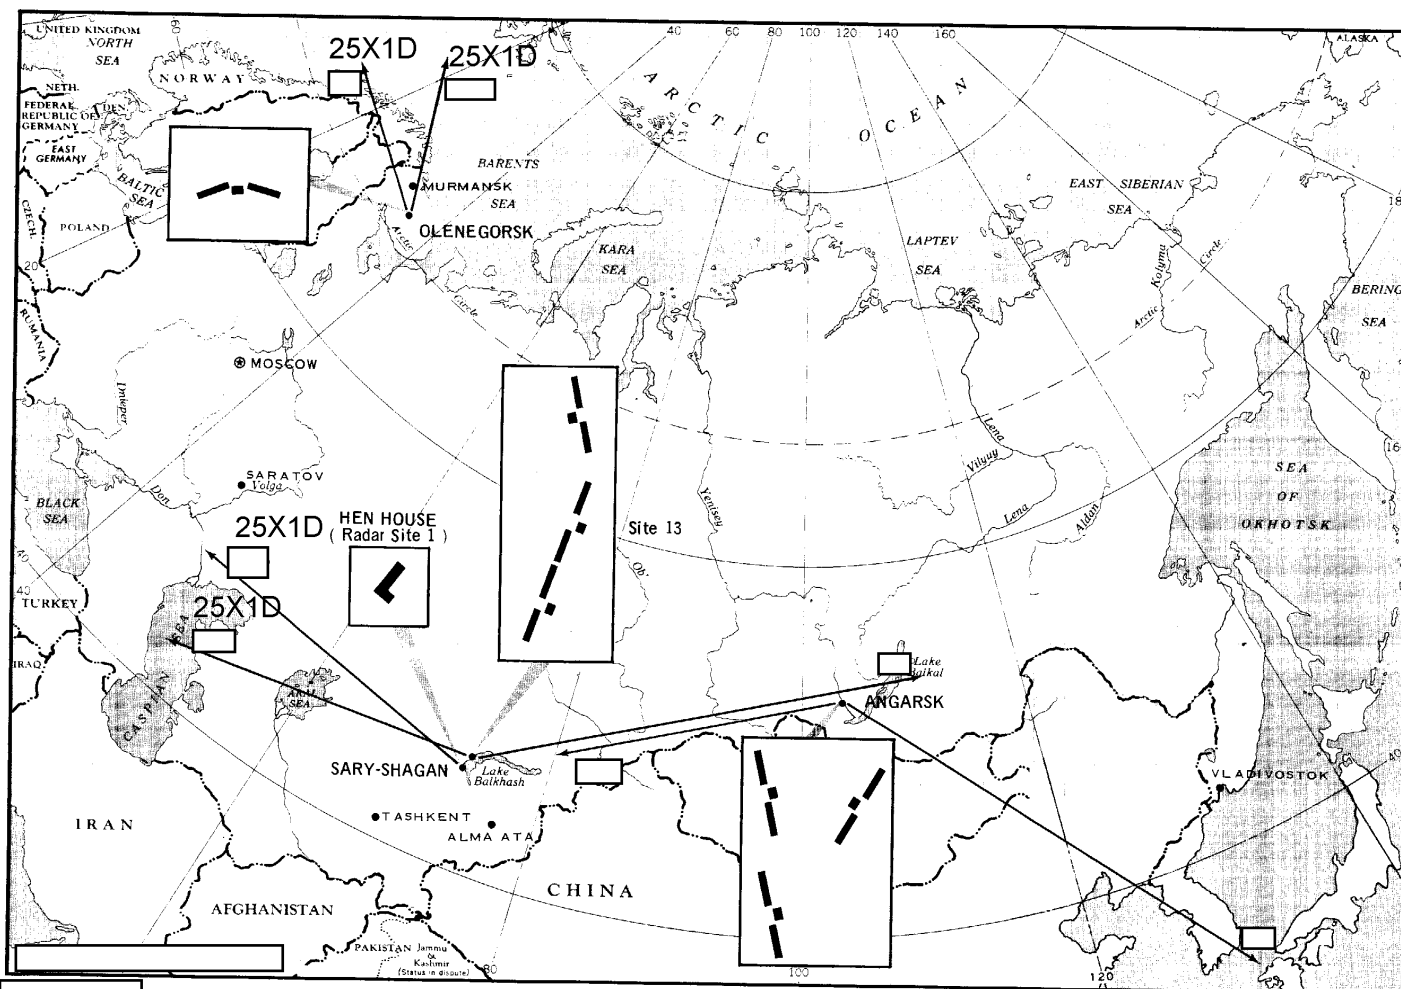
FIGURE 10. LOCATIONS OF HEN HOUSE-TYPE STRUCTURES, USSR.

A comparison between the HEN HOUSE-type structures at Site 13 and those at Angarsk and Olenegorsk can be found in Table 2 and on Figure 10. A more detailed textual comparison of the three installations can be found in NPIC report R-855/64.2/

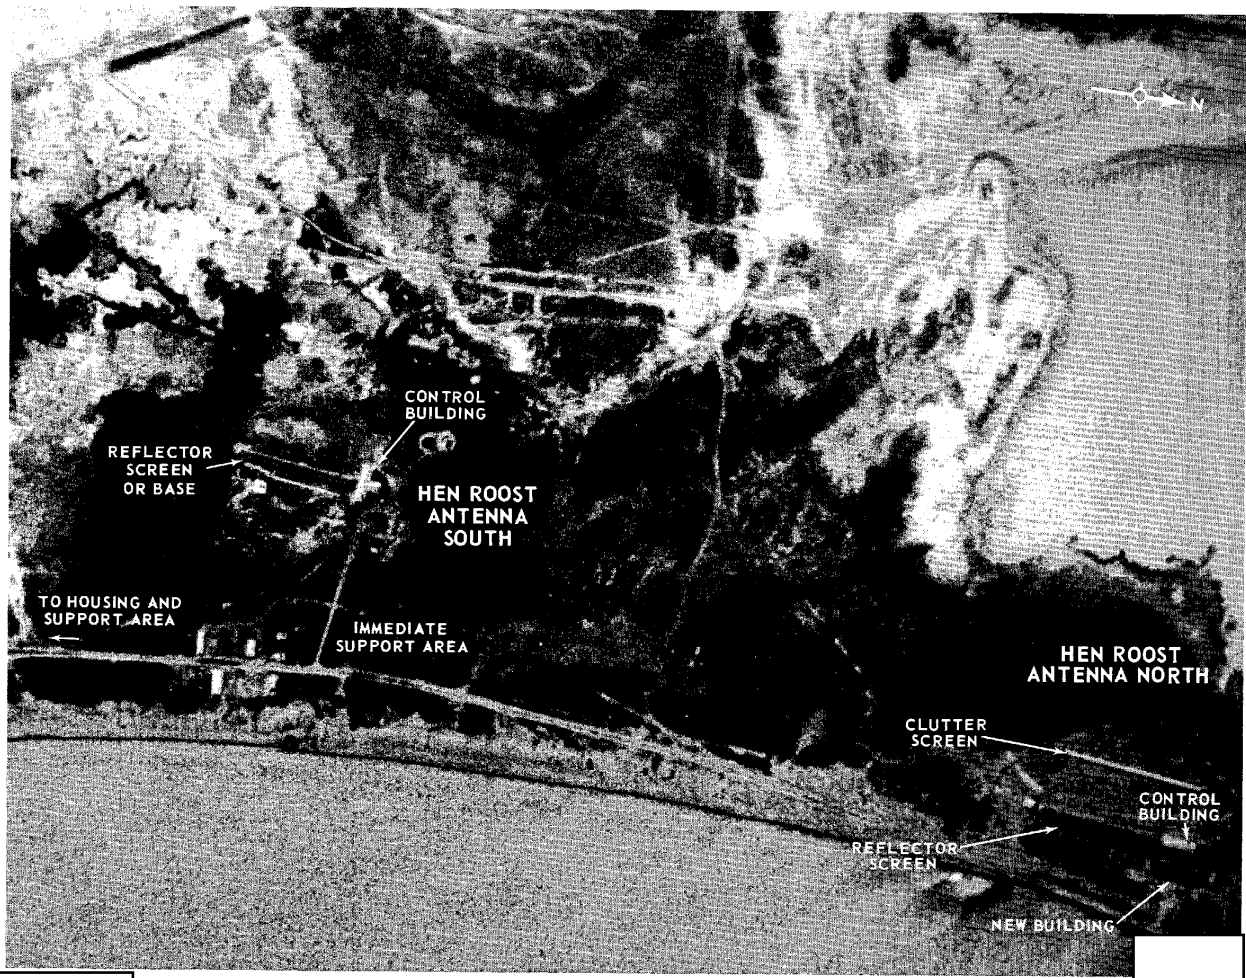
FIGURE 11. HEN ROOST ANTENNAS.

The building observed in initial construction stage in [] at HEN ROOST Antenna North paralleling and just east of the control building measures approximately 155 by 45 feet.

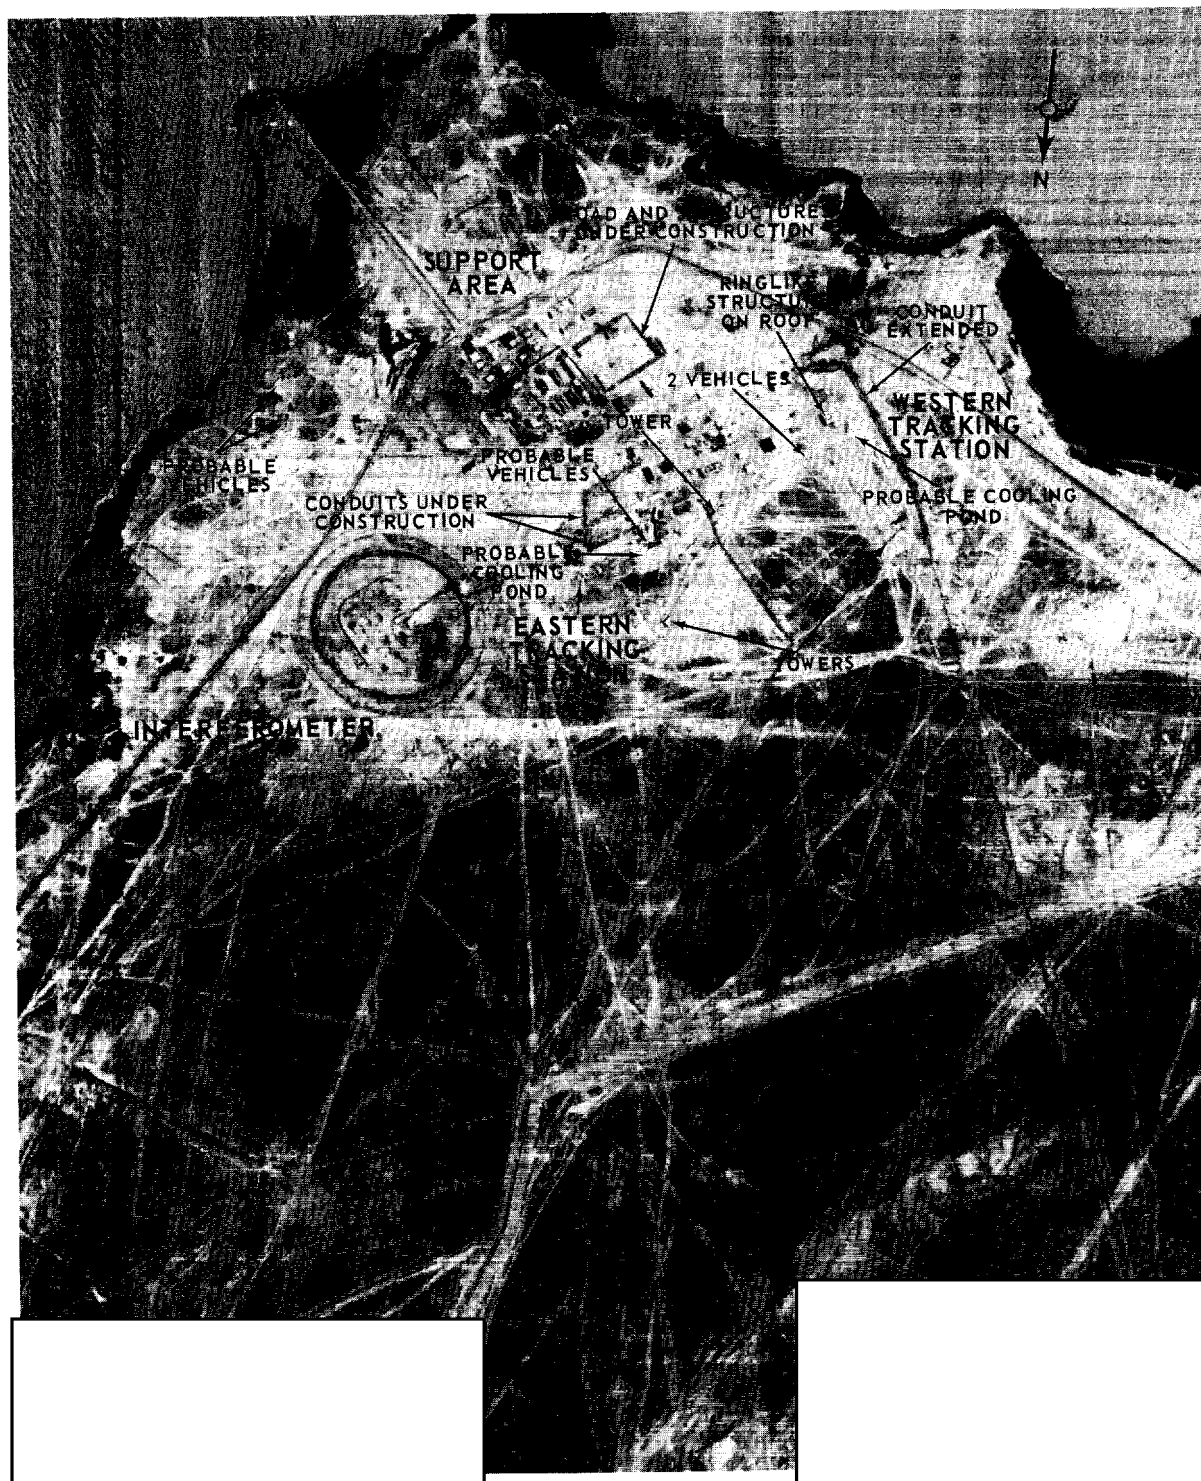
FIGURE 14. INSTRUMENTATION SITE 1.

The interferometer at this site (Figure 14) remains unchanged since [] and since last clear coverage of []. Between [] work began in the southwest corner of the support area on three structures and a U-shaped road system. The western 90- by 60-foot building in the western tracking station appears light in tone and now has a ringlike structure on the roof. A very small structure adjacent to the west side was not apparent before. The eastern 90- by 60-foot building of the tracking station is very dark in tone and the previously observed roof object is not discernible. Two vehicles are parked midway between the two buildings. The ground scar/conduit observed to extend in the snow in [] in a northerly direction to a possible calibration point remains and has been extended to a point just south of the 90- by 60-foot buildings. Both buildings (90 by 80 feet) in the eastern tracking station are light in tone and have probable environmental shelters on the roof centers. A possible crane is adjacent to the western building. Work continues on the

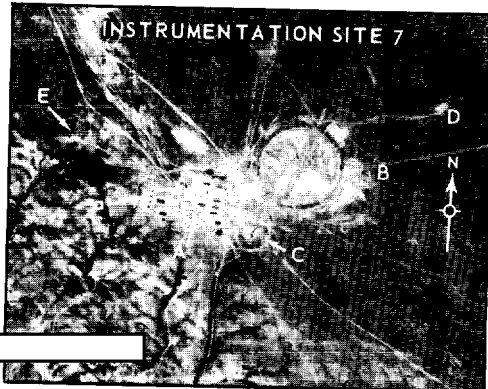
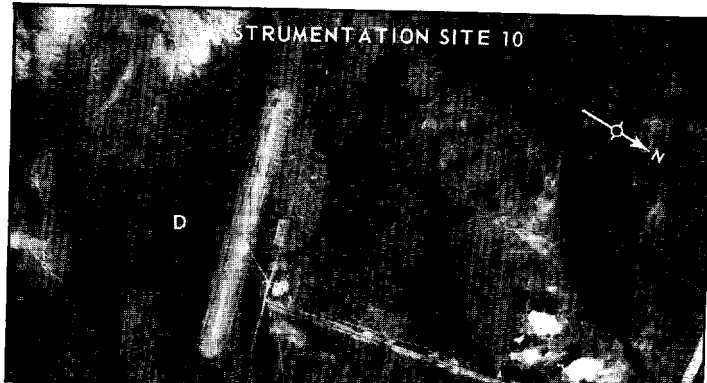
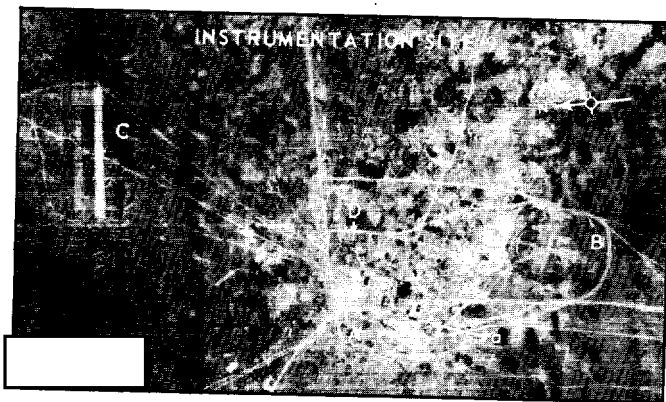
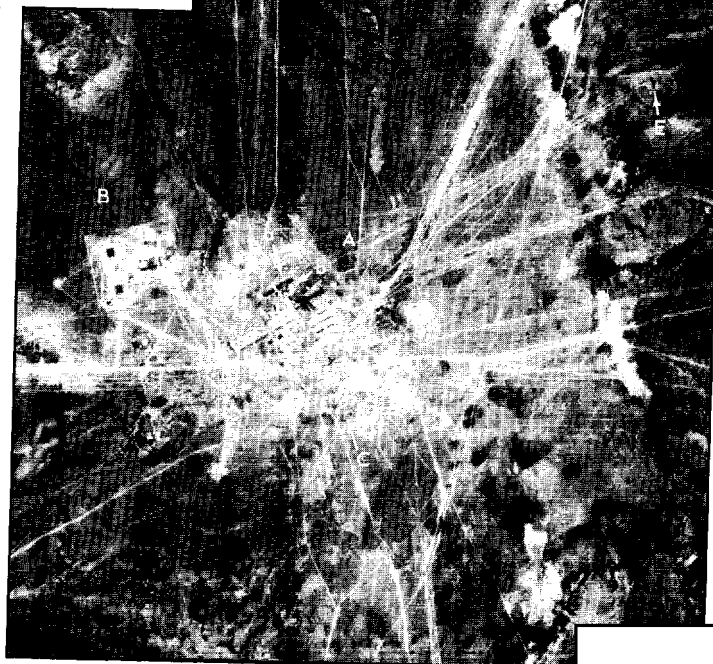
FIGURE 17. INSTRUMENTATION SITES 7, 8, 9, AND 10.

Instrumentation Site 7 (Figure 17) currently consists of an operational and support area (A) with 24 buildings and 4 additional small buildings each with a 20-foot-diameter dome (a); an interferometer with 1,000-foot long crossarms (B); a probable microwave tower (C); and an unidentified facility (D). No significant change has occurred at the site since Mission [] [] There is no evidence on current photography of a possible airstrip reported under construction in [] approximately 2.4 nm east-southeast of the interferometer. The site of the TOKEN-type radar (E) observed on [] photography just west of the support

This site (Figure 17) consists of an opera-tional and support area (A) having 32 buildings and 5 or possibly 6 buildings with 20-foot diameter domes (a); an interferometer with 1,000-foot-long crossarms (B); an airstrip (C); and a possible radar site (D). The airstrip ap-pears to have received some additional prepa-ration since Mission [] and now measures approximately 4,260 by 180 feet. Three structures with 20-foot-diameter domes were present in [] they had increased in number to five or possibly six. Five small structures or vehicles are observed in the two small areas southwest of the support area where [] photography of [] revealed the presence of a TOKEN-type radar. No statement can be made concern-ing the present existence of such a radar because of the small scale of the photography.
